Universal

TECHNICAL BULLETIN 004

This issue we look at unit identification

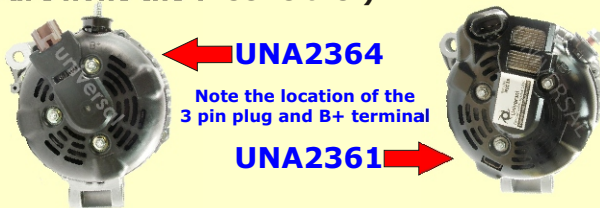
Landrover 2.7TD

This one is nice and straight forward. There are two types of alternator fitted to these vehicles (despite certain suppliers listing only one....). The difference being, those vehicles fitted with ACE are fitted with our part number UNA2364 whilst those vehicles without ACE are fitted with a UNA2361.

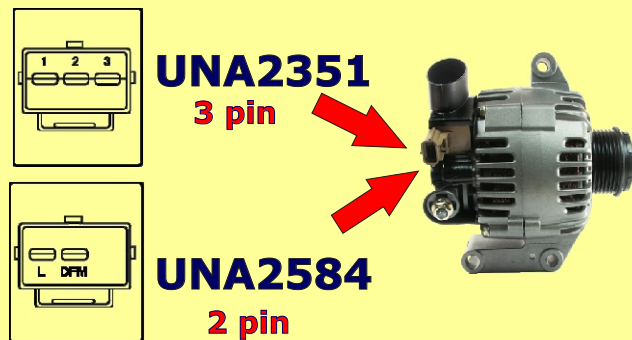
Mondeo ST220

This vehicle is fitted with two different options of alternator. These look identical except for the fact that one has a two pin plug and one has three. If the incorrect unit is fitted the warning light will stay on, however because the unit looks identical the fitter may start to look for all other possible problems (wiring etc). These units **MUST** be applied by O.E. numbers to guarantee the correct part is supplied. Below are the part numbers concerned.

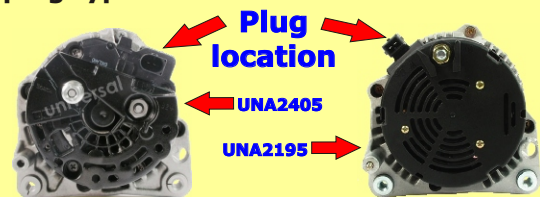
LDV Maxus

Again there are two different types of alternator fitted to this vehicle. However this one doesn't seem to have any vehicle differences associated with it. The LDV Maxus can be fitted with either a Bosch or an Iskra alternator. The easiest way to distinguish between the two is the plug. The Bosch unit (UNA2405) has an oval plug as part of the plastic backing, however the Iskra unit (UNA2195) has a rectangular plug sitting proud of the back.

They are not interchangeable and the only way to tell which one is fitted is either O.E. numbers or the plug type and location.
