TECHNICAL BULLETIN 012

I-StARS Stop/Start, Toyota & Landrover alternators and Scania starters

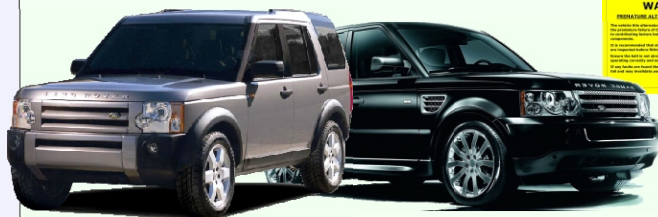
WARNING!
 REMOVED ALTERNATOR BEARING FAILURE.
 This vehicle application suffers with ignition switch problems. The switch must be checked or replaced prior to installation of the new starter motor. Failure to check or replace may cause the starter motor to continually engage, consequently it will eventually burn the starter motor out.

It has come to our attention that certain Landrover alternators are being returned with either damaged clutch pulleys or excessively worn and damaged bearings.

The vehicles and part numbers affected are the Discovery 3 2.7TD and the Range Rover Sport 2.7TD from 2005-2009, fitted with UNA2361 or UNA2364. When changing an alternator on these vehicles please inspect the clutch pulley for any damage and that it's functioning correctly.

If there is an issue it probably indicates that a vehicle tension fault needs rectifying before the fitment of the replacement alternator. This will now be covered by our latest WI information; WI-14 which will accompany each unit.
