## TECHNICAL BULLETIN 001

### STARTER MOTOR AND ALTERNATOR INSTALLATION NOTES AND TIPS

### VW TDI 2.5 DIESEL ALTERNATOR FAILURE

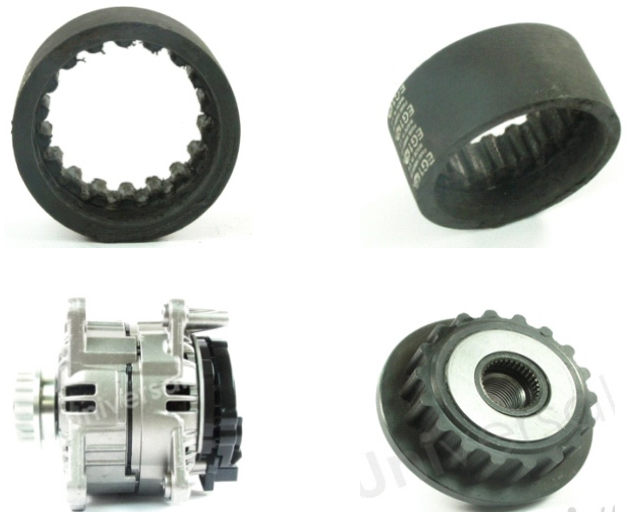
We have had feed back on the above vehicle having early alternator failure shortly after fitting the unit, this along with the rubber coupling and clutch pulley gear seizing. This is due to incorrect fitment of the unit. It is vital that the bottom bracket is aligned and tightened before the top brackets. If the top bracket is tightened first this will result in the alternator sitting off set which will cause the alternator to fail. Part numbers that are affected are: **UNA1579** and **UNA1580**.

#### Pictures of Damaged rubber coupling caused by incorrect fitting.
